DEPARTMENT OF TRANSPORTATION

Quality Assurance and Source Inspection

Contract #: 04-0120F4Cty: SF/ALA Rte: 80 PM: 13.2/13.9File #: 82.28**WELDING INSPECTION REPORT****Resident Engineer:**Siegenthaler, Peter**Address:** 333 Burma Road**City:** Oakland, CA 94607**Report No:** WIR-025373**Date Inspected:** 15-Jul-2011**Project Name:** SAS Superstructure**OSM Arrival Time:** 630**Prime Contractor:** American Bridge/Fluor Enterprises, a JV**OSM Departure Time:** 1500**Contractor:** Westmont Industries**Location:** Santa Fe Springs, CA**CWI Name:** Ruben Dominguez**CWI Present:** Yes No**Inspected CWI report:** Yes No N/A**Rod Oven in Use:** Yes No N/A**Electrode to specification:** Yes No N/A**Weld Procedures Followed:** Yes No N/A**Qualified Welders:** Yes No N/A**Verified Joint Fit-up:** Yes No N/A**Approved Drawings:** Yes No N/A**Approved WPS:** Yes No N/A**Delayed / Cancelled:** Yes No N/A**Bridge No:** 34-0006 L & R**Component:** Maintenance Travelers**Summary of Items Observed:**

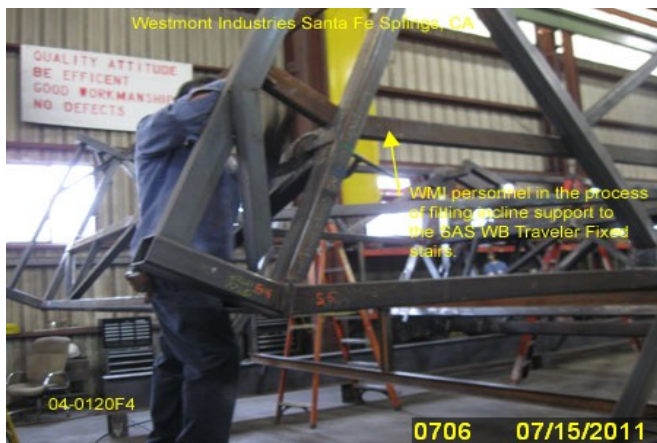
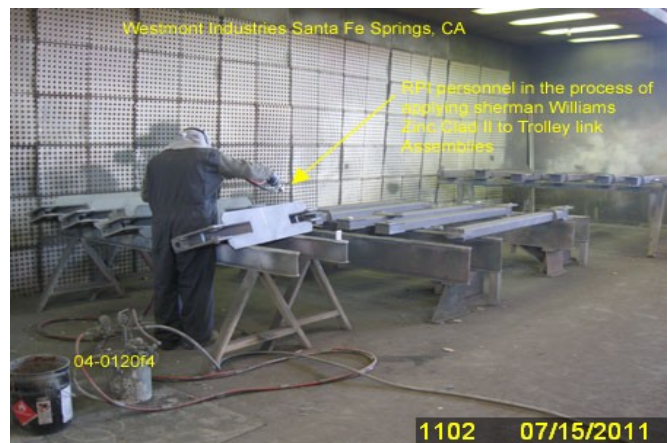
Later in the shift, this QA Inspector randomly observed RPI Coating performing what appeared to be primer application activities within what appeared to be within an 8 hour time frame from the above mentioned blasting activities. Environmental readings taken by RPI at the time of primer application are as follows respectively: Air Temperature 69 F, Relative Humidity 58%, Wet Bulb Temperature 60 F, Dew point 54 F and Surface Temperature 68 F.

QA Inspector performed measurement on dry coating thickness with Type 2 (magnetic gage), DFT's thickness reading of the prime coated Trolley Links Assemblies prime coated on 07-14-11 are an average of three (3) thickness readings as follows 5.6 mils, 6.1 mils, 6.1 mils, 4.6 mils, 6.1 mils, and 4.6 mils. QA Inspector also, observed Mr. Nunez documenting daily activities on RPI Coating QC Daily Inspection Report. Note: RPI Coating Mr. Miguel Nunez informed QA Inspector that RPI is going to also abrasive blast 15 additional Trolley Links Assemblies but will not be able to apply the prime coating today, but will sweep blast on Monday 7-18-11 perform test and prime coat. QA Inspector Caltrans Representatives SMR Mr. Nicolai Hvass of the above information on this date.

Note: The above mentioned Trolley Link Assemblies had been previously abrasive blasted and primed coated and was determined by Sherman Williams Representative Mr. Eric Anderson, RPI Coating Mr. Gary McDonald and RPI Coating Mr. Carlos Torres that RPI Coating that RPI had greatly exceeded the 3.4 mils to 5.9 mils for prime coating requirements and made the decision to re-blast and re-prime Trolley Link Assemblies. RPI Coating Mr. Gary McDonald and RPI Coating Mr. Carlos Torres will also reevaluate the E2/E3 EB Traveler prime coating thickness at a later date.
